June 28, 2019
File No. 262018.063

Subject: Department of Natural Resources Washington Geological Survey,
School Seismic Safety Assessment Project, Contract No. AE 410 -
Seismic Evaluation for **Puyallup School District**

School Buildings Evaluated in the Puyallup School District

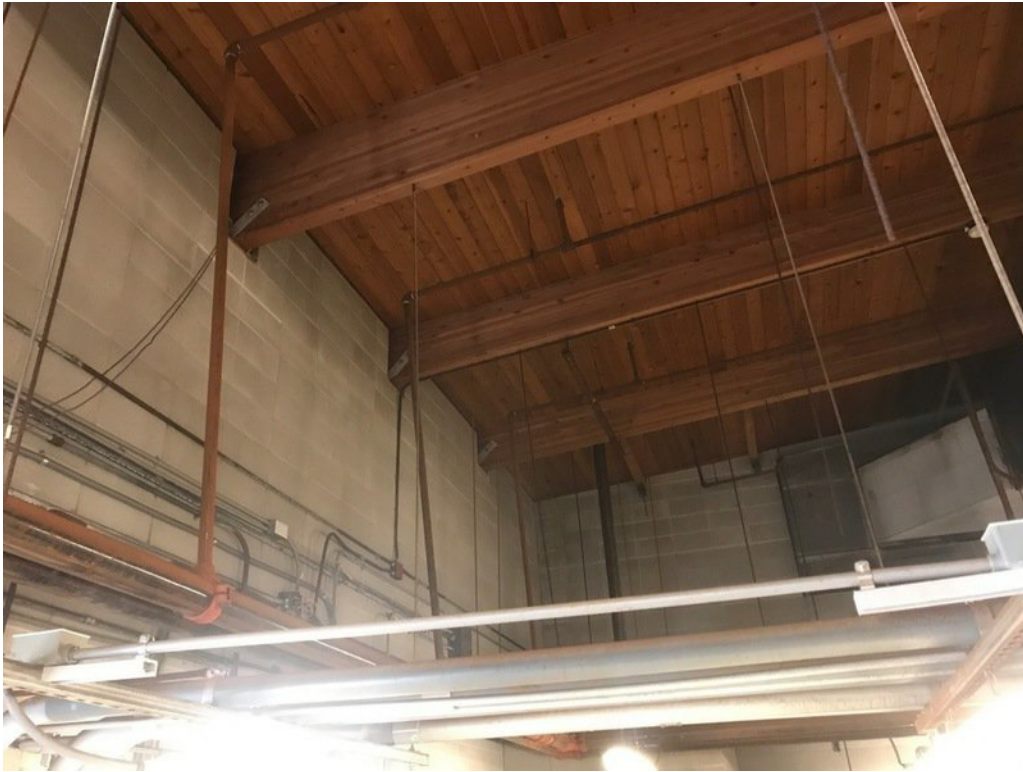
Figure 1-9. Exposed glu-lam beams - mechanical room in swimming pool structure

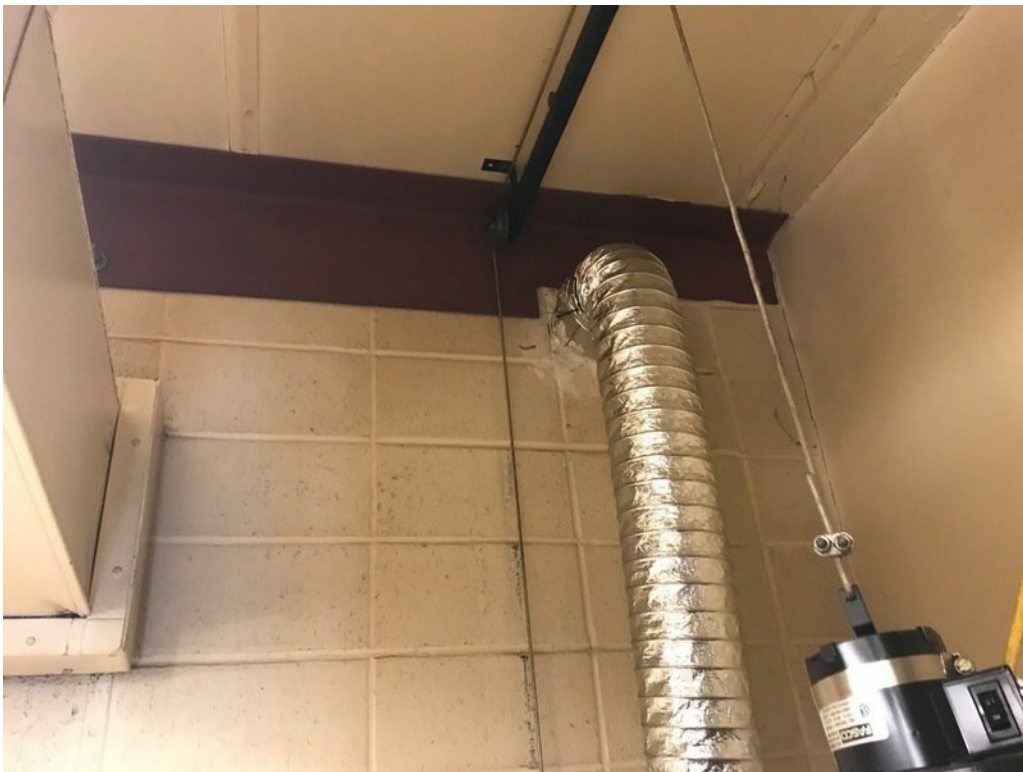
Figure 1-10. Bent plate in a janitor closet that looked like it could be part of a seismic upgrade.
